Property Inspection Report

123 Sample Address, Austin, TX 78712
Inspection prepared for:
Date of Inspection: 7/1/2019 Time: 1:00 PM
Age of Home: 1975 Size: 1232
Order ID: 520

Prepared For:	<u>Scott MacDonald</u>	
	<small>(Name of Client)</small>	
Concerning:	<u>4405 Dovewood, Austin TX, 78744</u>	
	<small>(Address or Other Identification of Inspected Property)</small>	
By:	<u>Don Barker, License # 3271</u>	<u>7/1/2019</u>
	<small>(Name and License Number of Inspector)</small>	<small>(Date)</small>

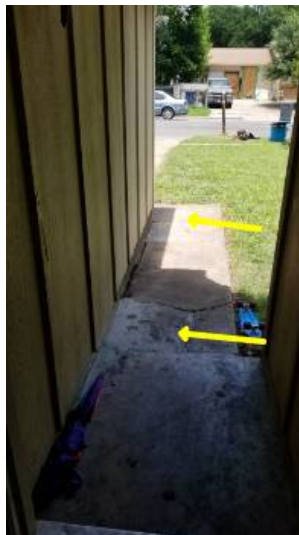
A.2. Previous foundation repairs observed on front sidewalk concrete.

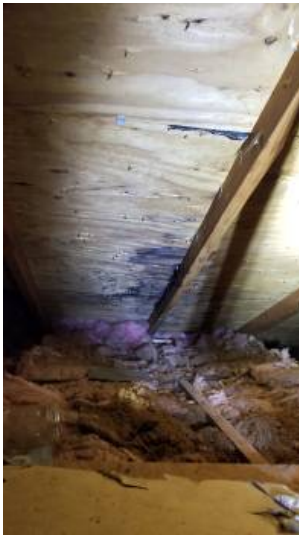
D.1. Roof wood decking shows signs of water damage on the front side.

Roof wood decking shows signs of water damage on the front side.

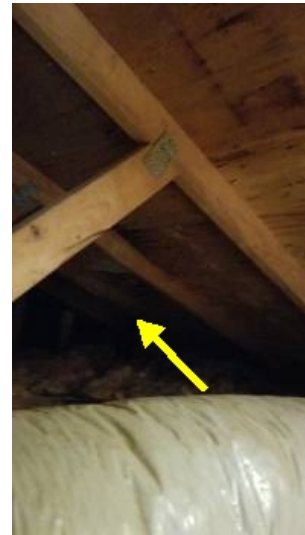
Roof wood decking shows signs of water damage on the front side.

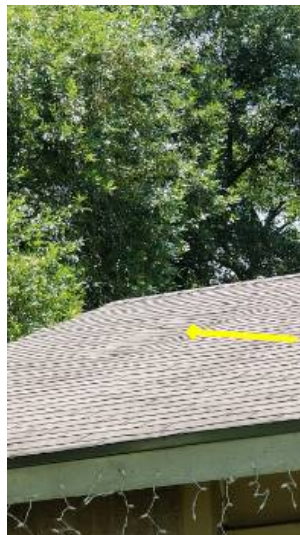
D.3. Roof decking is cupping in several places on the front side of the of the roof.

roof decking damage on the front left corner of the house

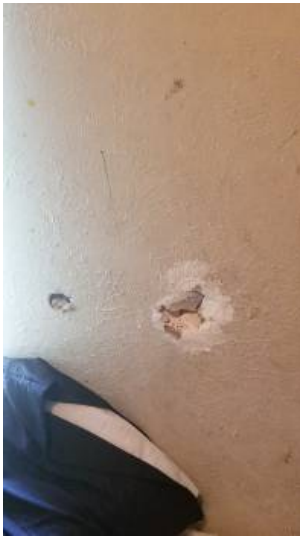
E.1. Left front bedroom- sheetrock is damaged on the front and right walls.

damaged sheetrock left front bedroom

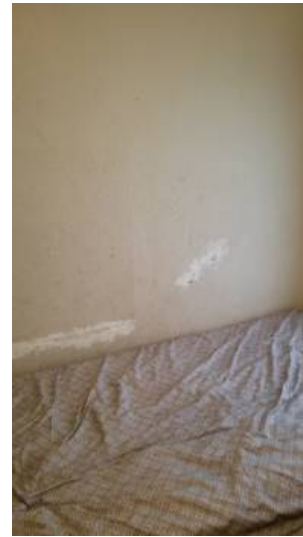
damaged sheetrock left front bedroom.

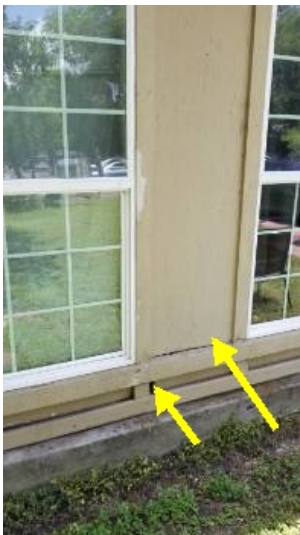
E.2. Exterior siding and trim is rotted in several places on all sides of the house.

siding and trim damaged front side.

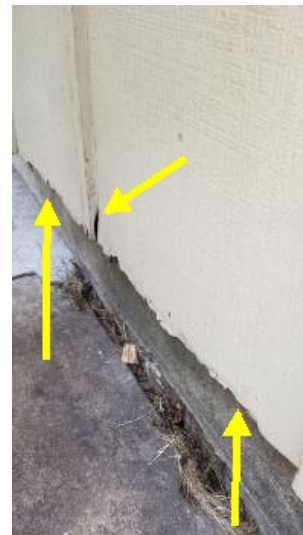
siding and trim damaged left side of converted garage.

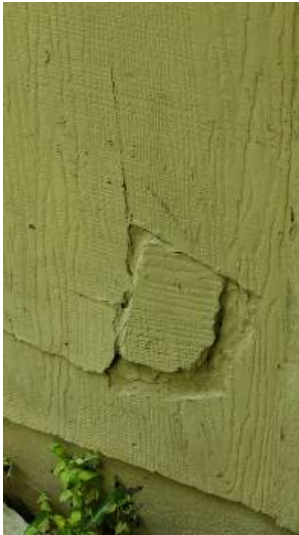
damaged siding on the left side of the house

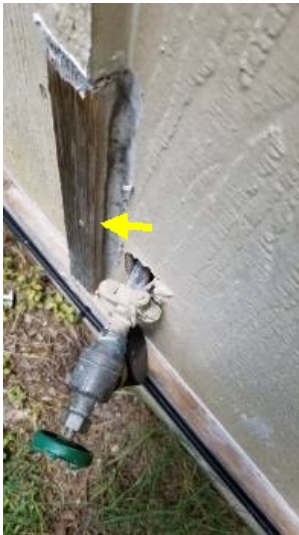
damage wall trim

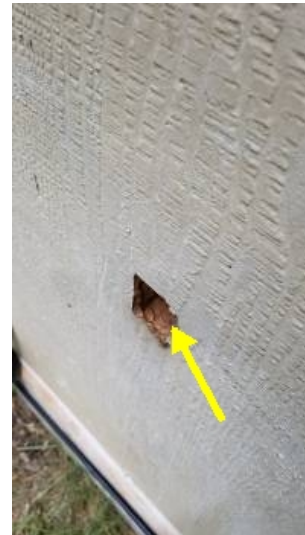
hole in the siding on the right side of the house

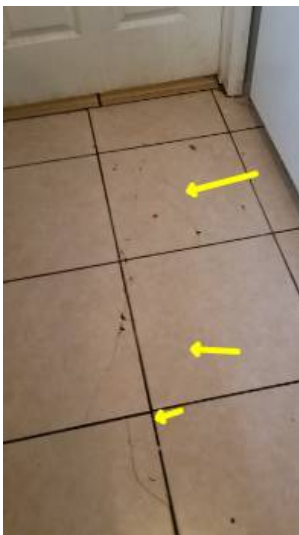
kitchen floor tiles cracked.

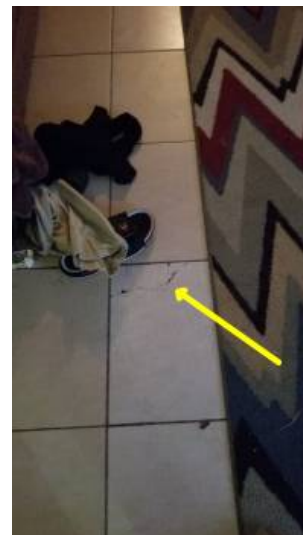
living room floor tiles crack

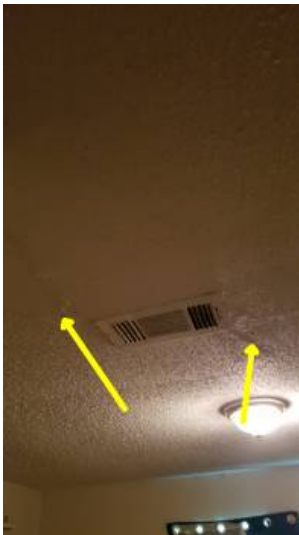
ceiling sheetrock cracked and sagging

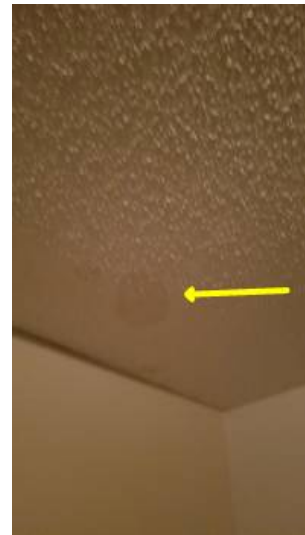
water stain on ceiling sheetrock.

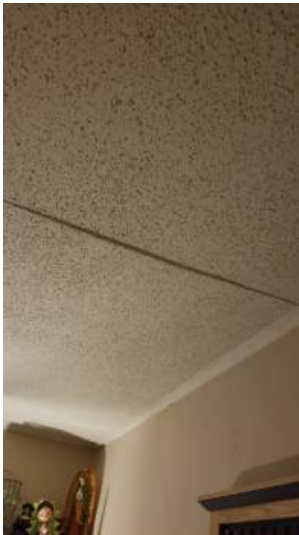
converted garage ceiling sheetrock sagging.

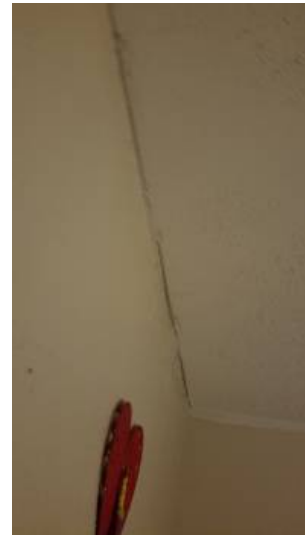
garage ceiling sheetrock sagging.

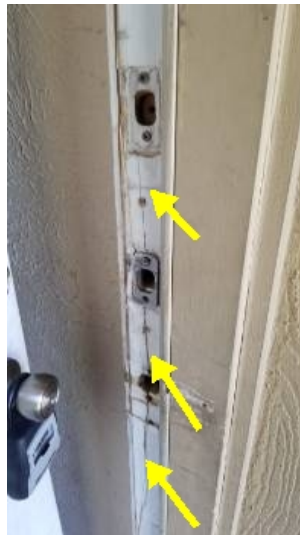
Front door jamb is damaged at the striker plate area.

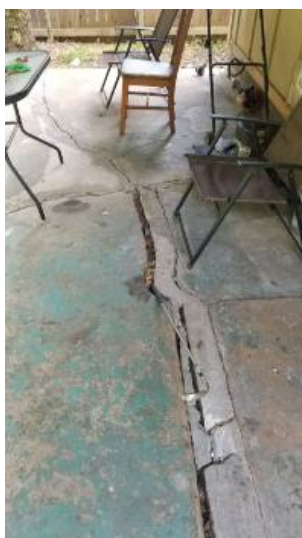
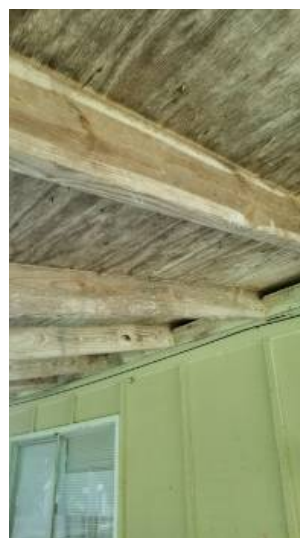
K.1. Back patio concrete slab is cracked and lifted in several areas.

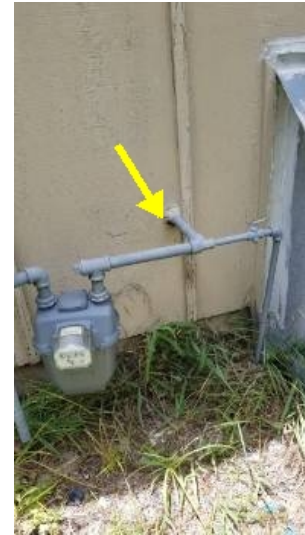
Gas lines are not bonded to electrical panel. Wasn't required when house was built.

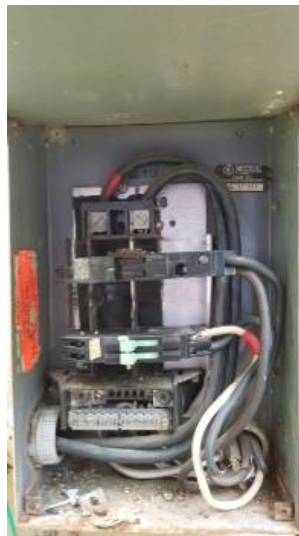
Both electrical panel boxes are zinco brand. These electrical panel boxes are considered a safety hazard. Recommend replacing electrical panel boxes.

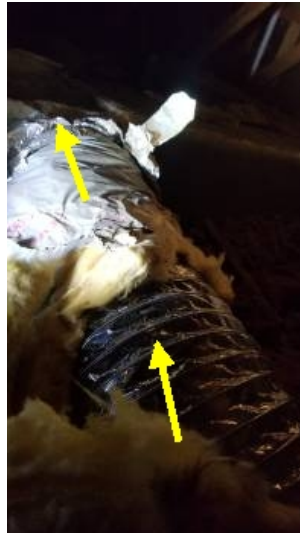
C.1. AC ductwork for converted garage area- flex duct insulation is damaged on the flex duct work. Poor connection from the flex ductwork to the flex board ductwork.

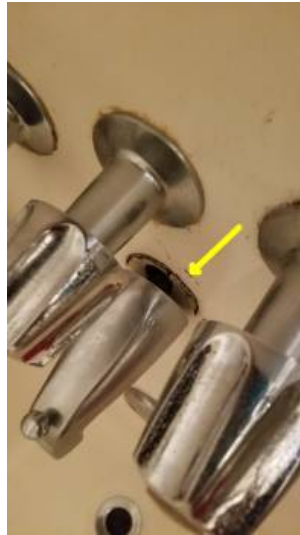
A.2. Hall bathroom tub faucet spout is not installed correctly. Tub spout is an inch and a quarter away from the wall.

tub spout

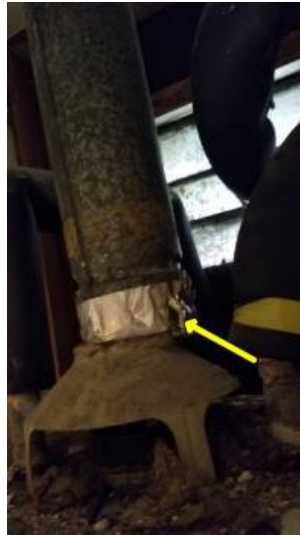
Water heater vent pipe is not connected to the water heater vent hood.

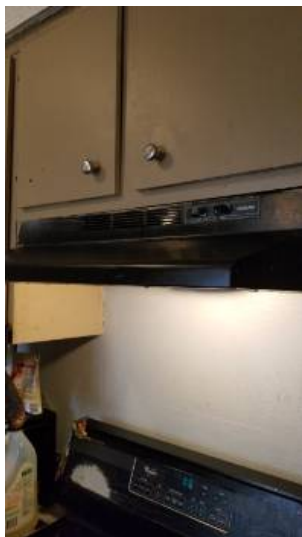
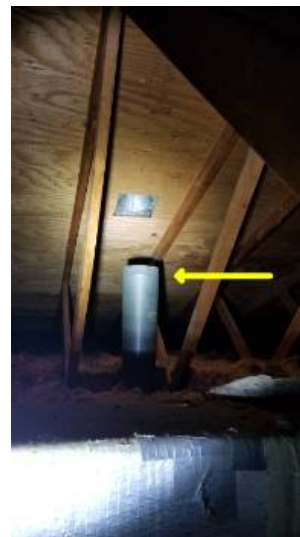
C.2. Range hood vent pipe terminates in the Attic. Fire safety hazard.

range hood vent pipe terminates in attic.
